Facility Name-Field Inspection Supplemental Photo Information

This information is provided to supplement the summary walkthrough inspection of the ABC , Inc. facility conducted on 12/13/14, by Tony Kuehn, ILC. This information should be viewed as supporting information relating to specific items identified during the summary walkthrough of the facility.

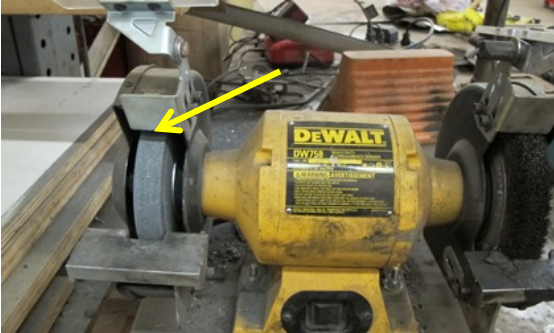
<u>Comment</u>	<u>Photo</u>
<p>Bench Grinder in work area needs to have the tongue guard adjusted. The upper guard (Tongue) needs to be adjusted to be within ¼ inch of the abrasive wheel.</p> <p>29 CFR 1910.215(a)(4) Abrasive Wheel Machinery - Work Rests</p> <p>Item ID: 1 Assigned to: _____, on _____ (date) To be completed by _____. Date completed: _____.</p>

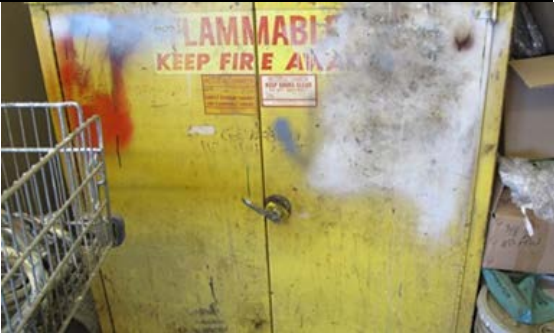
<p>Flammable storage cabinet in the parts room has a non-functional closure on the door. The cabinet should be of the self-closing type to meet MN Fire Codes and 29 CFR 1910.106 (e) (2) (ii). This is an outstanding item from previous inspections. The door latch needs to be repaired</p> <p>Item ID: 2 Assigned to: _____, on _____ (date) To be completed by _____. Date completed: _____.</p>
